FlightLine

A Monthly Publication of Collins Model Aviators

August 1996

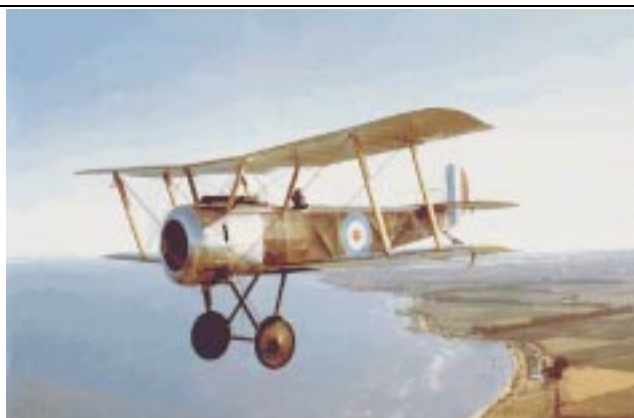
August's Featured Model — Sopwith Pup in flight from Allan Wright's W.W.I modeling Web page

maneuverability speed and rate of climb, and in August of 1917 it became the first plane to land on a moving ship, the HMS Furious.

The Sopwith Pup (also known as the Scout Tractor) was the precursor to the famous Sopwith Camel. The Camel was the most successful fighter of World War I, shooting down more enemy aircraft than any other plane of the war. But the Pup was memorable in it own right. The Pup had excellent

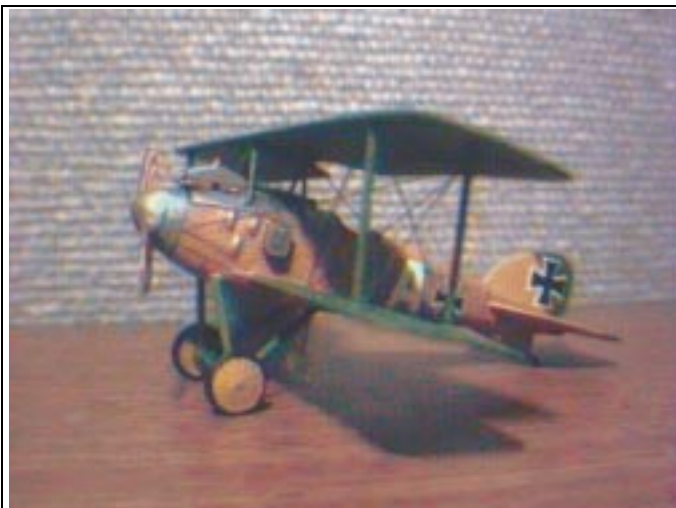
Allan Wright's W.W.I Albatros model

Allan Wright's Albatros model shown in the picture is actually a DIII kit modified to look like a DI by adding scratch built wings, wing struts, Windorf radiators, radiator overflow tank, and modifying the tail position and fuselage shape.
